# Army Lodging Wellness Recommendation

Fort Knox

August 13, 2003

**3D/I**

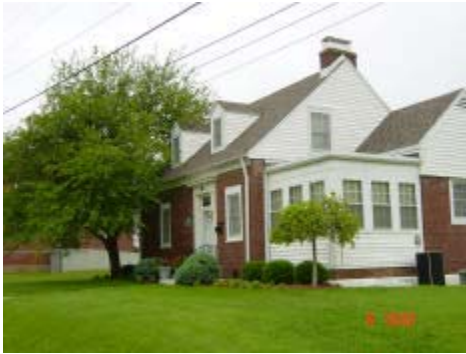
***Lodging Buildings 1117 (Yeoman Hall)***

Building 1117, constructed in 1935, has the equivalent of 10 family suites. This facility does not meet current Lodging standards and is in poor condition. The cost to make condition assessment improvements will exceed the 50% replacement cost.

Our recommendation is to remove building 1117 from the Lodging inventory, allowing the installation to determine an alternate use for the facility. This facility will be removed from the Fort Knox Wellness Solution and Lodging Master Plan.

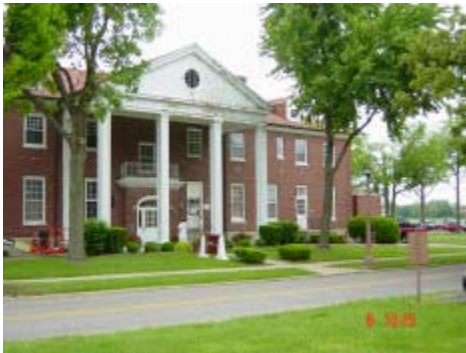
***Lodging Building 1120 (Henry House)***

Building 1120, constructed in 1934, has the equivalent of one multi-room family suite. This building is in poor condition and does not meet current Lodging standards. The cost to make condition assessment improvements will exceed the 50% replacement cost.

Our recommendation is to remove building 1120 from the Lodging inventory, allowing the installation to determine an alternate use for the facility. This facility will be removed from the Fort Knox Wellness Solution and Lodging Master Plan.

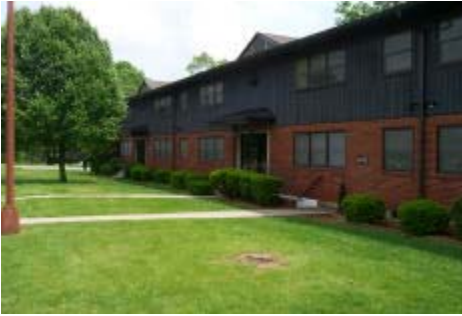
***Lodging Buildings 2441, 2443, 2444, 2445, 2446, 2447, 2448, and 2449 (Craig Apartments)***

These eight buildings, constructed in 1962, are located near the training area of the installation. Each building has 12 family suites, although Building 2443 has diverted one room to administrative uses. These buildings are in poor condition and do not meet current Army Lodging standards. The cost to make condition assessment improvements will exceed the 50% replacement cost.

Our recommendation is to remove these buildings from the Lodging inventory, allowing the installation to determine an alternate use for the facilities. These facilities will be removed from the Fort Knox Wellness Solution and Lodging Master Plan.

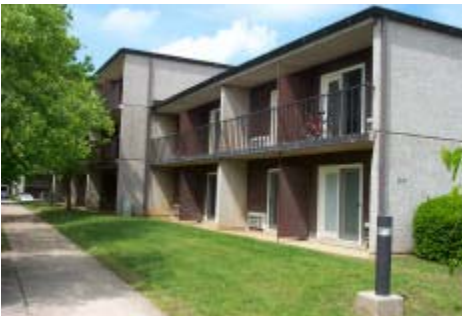
***Lodging Buildings 2602, 2603, 2604, 2605, 2606, 2607, and 2608 (Steindam Apartments)***

These seven buildings, constructed in 1974, are located near the training area and house extended stay rooms, with the exception of building 2608. Building 2602 has 26 rooms, 2603 has 44 rooms, 2604 has 8 rooms, 2605 has 24 rooms, 2606 has 26 rooms and 2607 has 45 rooms. Building 2608 houses administrative and supply storage functions only. These buildings are in poor condition and do not meet current Army Lodging standards. The cost to make condition assessment improvements will exceed the 50% replacement cost.

Our recommendation is to remove these buildings from the Lodging inventory, allowing the installation to determine an alternate use for the facilities. These facilities will be removed from the Fort Knox Wellness Solution and Lodging Master Plan.

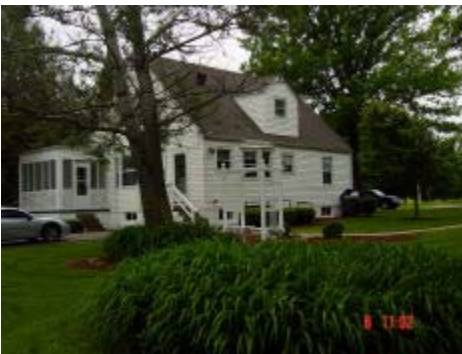
***Lodging Building 4016 (St. George House)***

Building 4016, constructed in 1942, has the equivalent of 1 DVQ family suite. This building is in poor condition and does not meet current Army Lodging standards. The cost to make condition assessment improvements will exceed the 50% replacement cost.

Our recommendation is to remove building 4016 from the Lodging inventory, allowing the installation to determine an alternate use for the facility. This facility will be removed from the Fort Knox Wellness Solution and Lodging Master Plan.

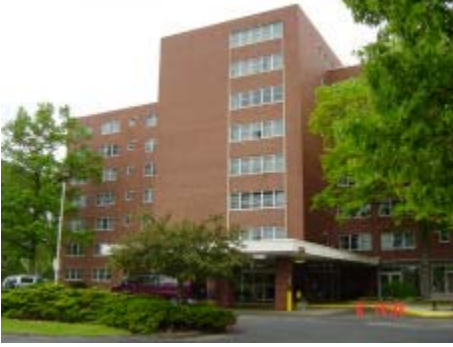
### ***Lodging Building 4770 (Newgarden Apartments)***

Building 4770, constructed in 1954, is located near Highway 31W, and it houses 16 family suites, 180 extended stay rooms, and the majority of the current Lodging support functions for the installation. The building is in very poor condition and does not meet current Army Lodging standards. The cost to make condition assessment improvements will exceed the 50% replacement cost.

Our recommendation is to remove building 4770 from the Lodging inventory, allowing the installation to determine an alternate use for the facility. This facility will be removed from the Fort Knox Wellness Solution and Lodging Master Plan.

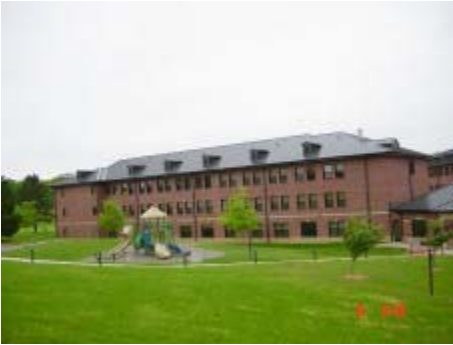
### ***Lodging Building 7961 (Wickam Guest House)***

Building 7961, constructed in 1998, is the newest Lodging facility on the installation and is located adjacent to one of two golf courses. This building houses 55 standard rooms, 50 family suites, and some of the current Lodging support functions for the installation. The building is in good condition and meets a majority of the current Army standards. The cost to make improvements and bring this building up to the new standards will not exceed the 50% replacement cost.

Our recommendation is to retain building 7961 in the Lodging inventory and continue to serve as part of the Fort Knox Wellness Solution and Lodging Master Plan.

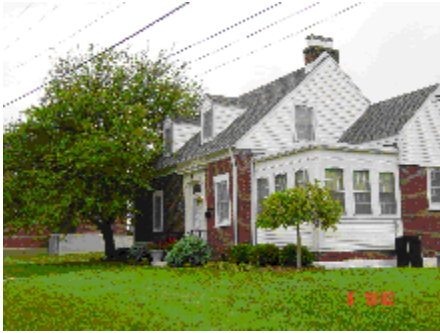
## Building 1004

Condition Assessment Cost	\$256,420.00
Replacement Cost	\$483,895.00
Condition Assessment to Replacement Cost Ratio	52.99%

Because the Condition Assessment to Replacement Cost Ratio is greater than 50%, renovation of Building 1004 is not recommended.

- Analysis: The steeply pitched roof is wood truss with wood 1x decking. The roof is supported by a wood frame structure. The superstructure is in good condition. The gutters are in fair condition.
- Recommendation: Replace the gutters.

- Analysis: The windows are wood, double-glazed sliders. They are in fair condition.
- Recommendation: Replace the windows.
